# **2018-2019 CAPITAL BUDGET REQUEST**

## **REPAIRS TO DAMAGED GRANITE ARCH STRUCTURES IN WESTMORELAND AND WALPOLE**

**On the NH DOT owned  
Cheshire Branch railroad corridor**

**NH DOT Bureau of Rail & Transit**

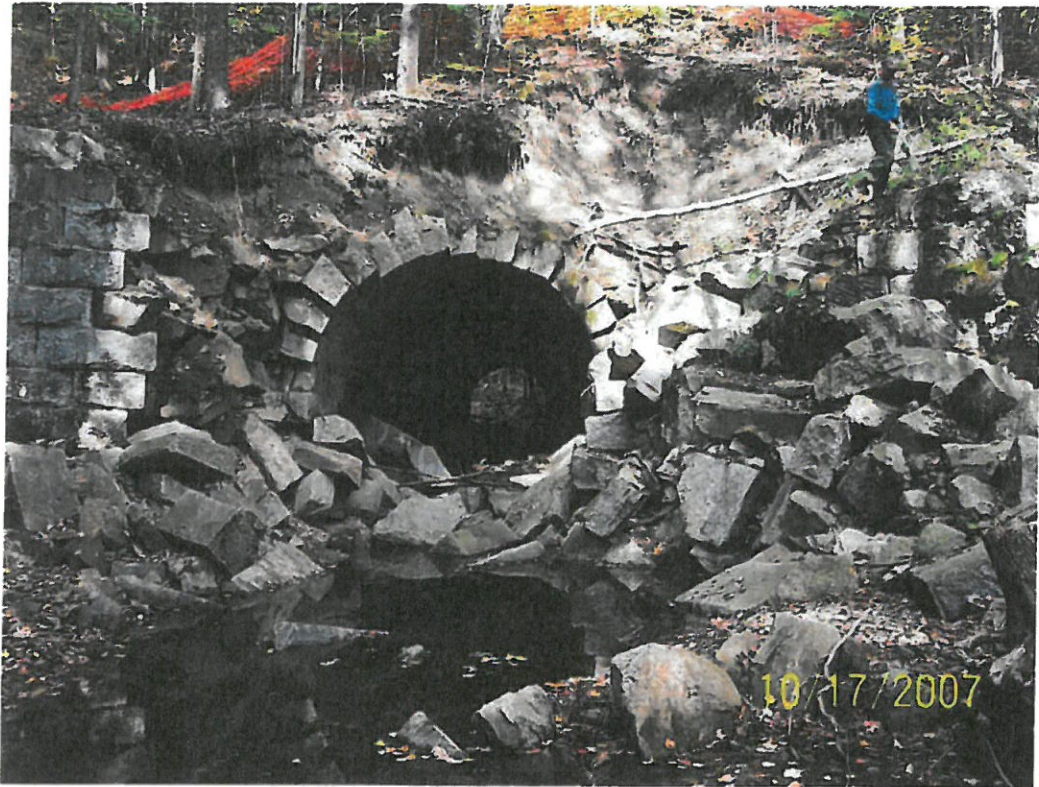
**View of 2007 Arch Collapse**

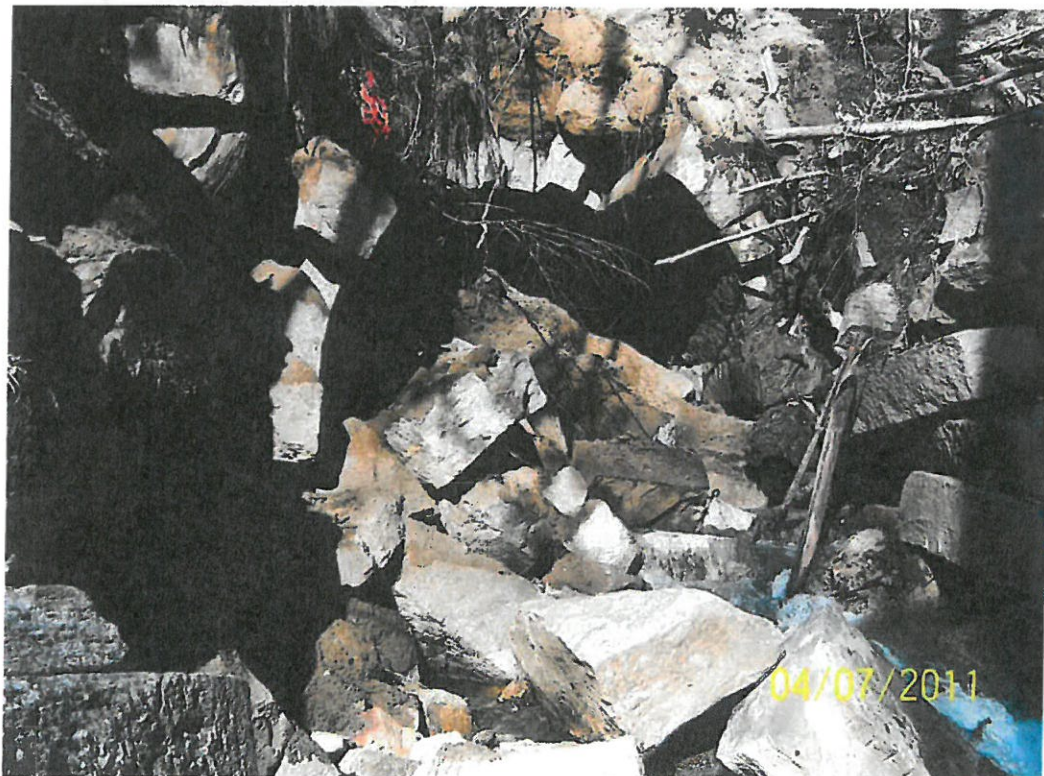
**View of 2011 Arch Collapse**

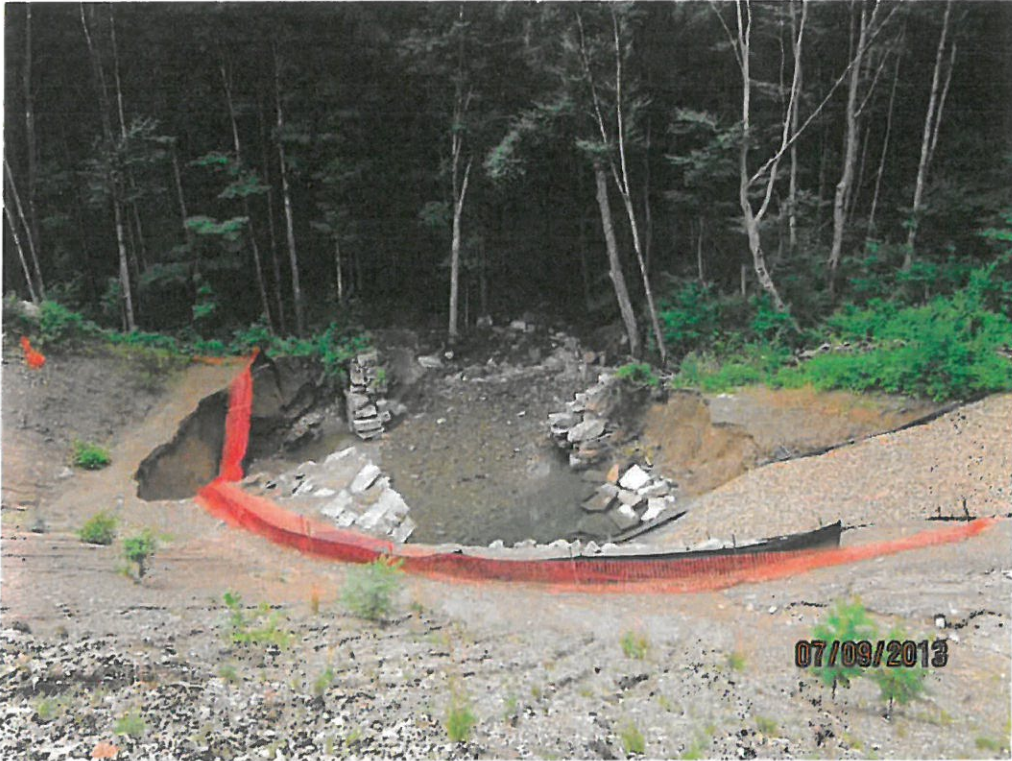
**View of Arch Damage from July 2013 Storm**

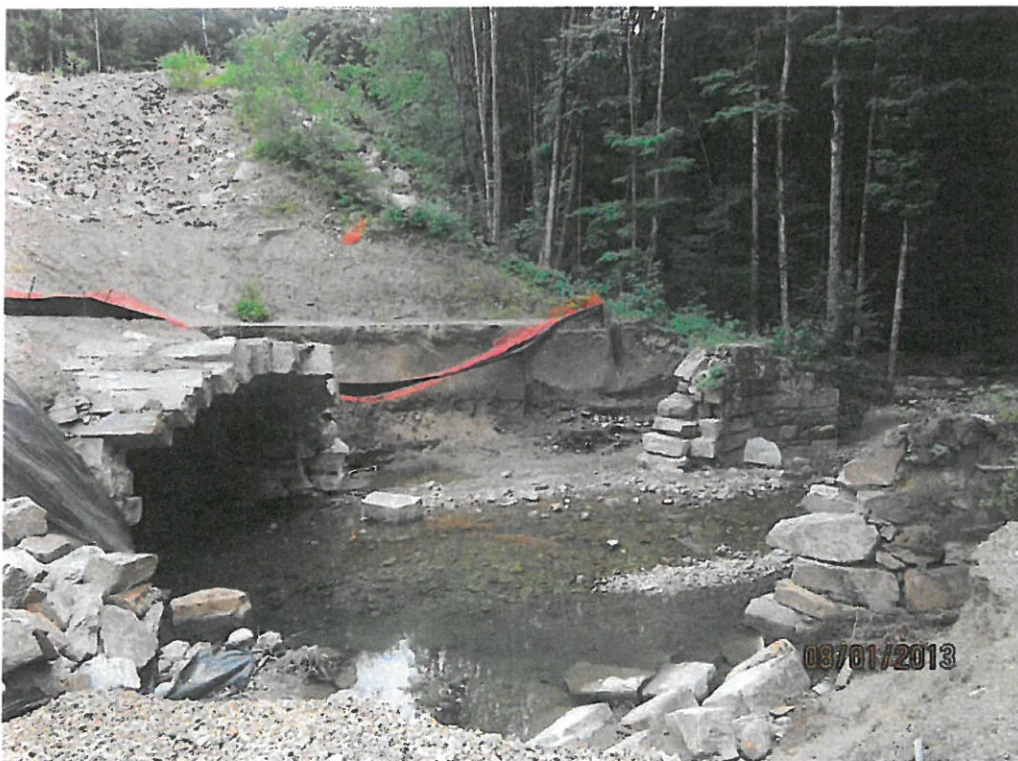
**Close-up View of Arch Damage from July 2013 Storm**

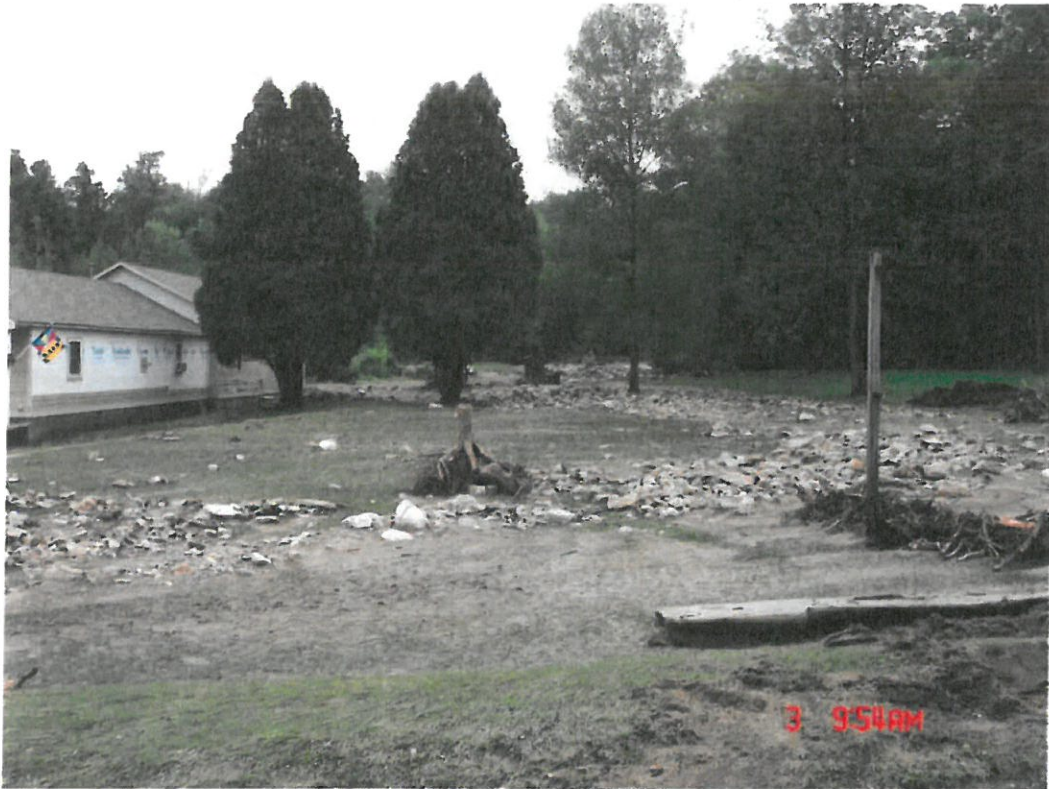
**View of Downstream Flood Damage at Route 12 from July 2013 Storm**

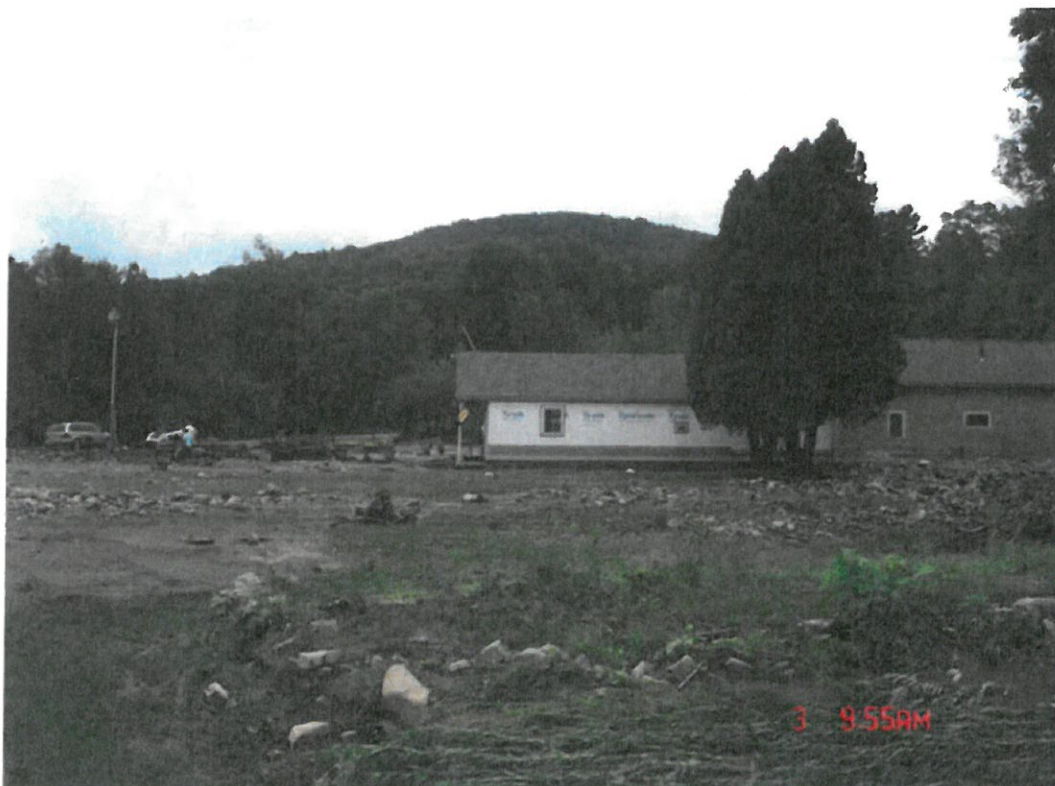
**View of Downstream Flood Damage at Route 12 from July 2013 Storm**

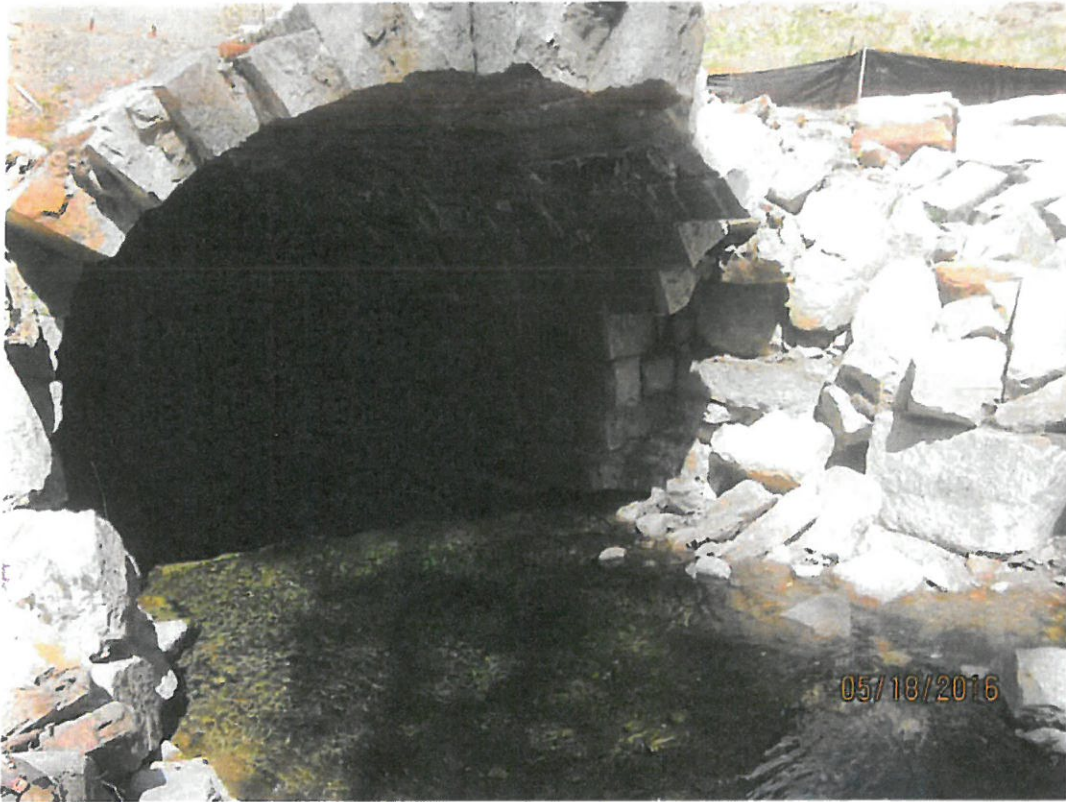
The critical part of granite arches are the foundation blocks that support the arch. At these two arches the foundation blocks are already partially undermined and susceptible to further erosion. If these blocks become totally undermined by water flow and become loose or fall out, then the blocks above become unstable and begin to move and eventually fall out causing that portion of the arch to collapse.

**View of Undermined Right Side of Arch**

The majority of the requested funds will be used to construct a new headwall on the outlet end of the Westmoreland granite arch to permanently stabilize the arch. The remaining funds will be used for engineering, plan preparation, DES permits, constructing rip rap outlet side slopes and completing the permanent restoration of the embankment slopes over the arch.

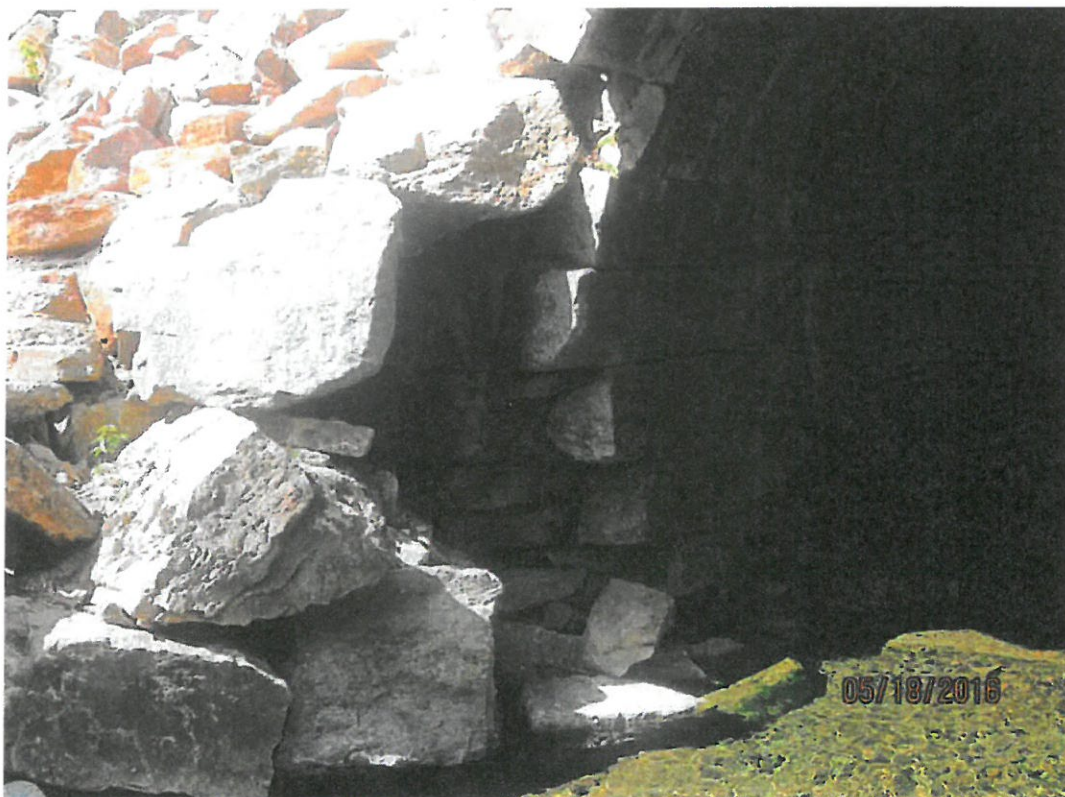
**View of Undermined Left Side of Arch**

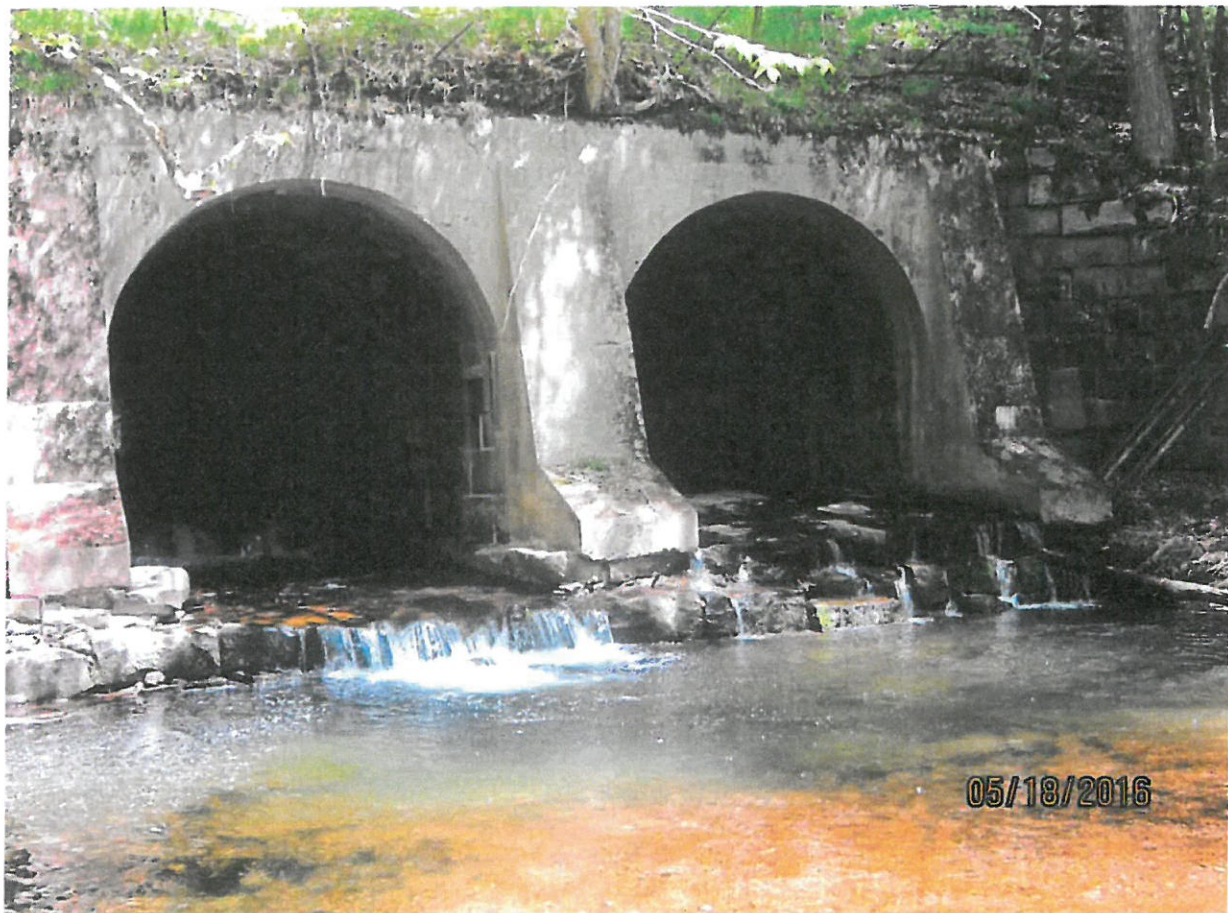
**Current View of Arch Showing Deterioration at Outlet End**

The majority of the requested funds will be used to construct a concrete floor at the end of the north arch and a new concrete spillway wall at the outlet end of both arches. The work is required to prevent future damage and possible collapse of the arch, the cleanup cost of which could exceed \$700,000. The remaining funds will be used for engineering, plan preparation, NH DES permits, constructing site access and constructing rip rap outlet protection. The Department has made emergency repairs in the past, but major repairs still remain to be made at this arch to ensure that the arch is stabilized and not in danger of future deterioration and possible collapse during a severe storm event.

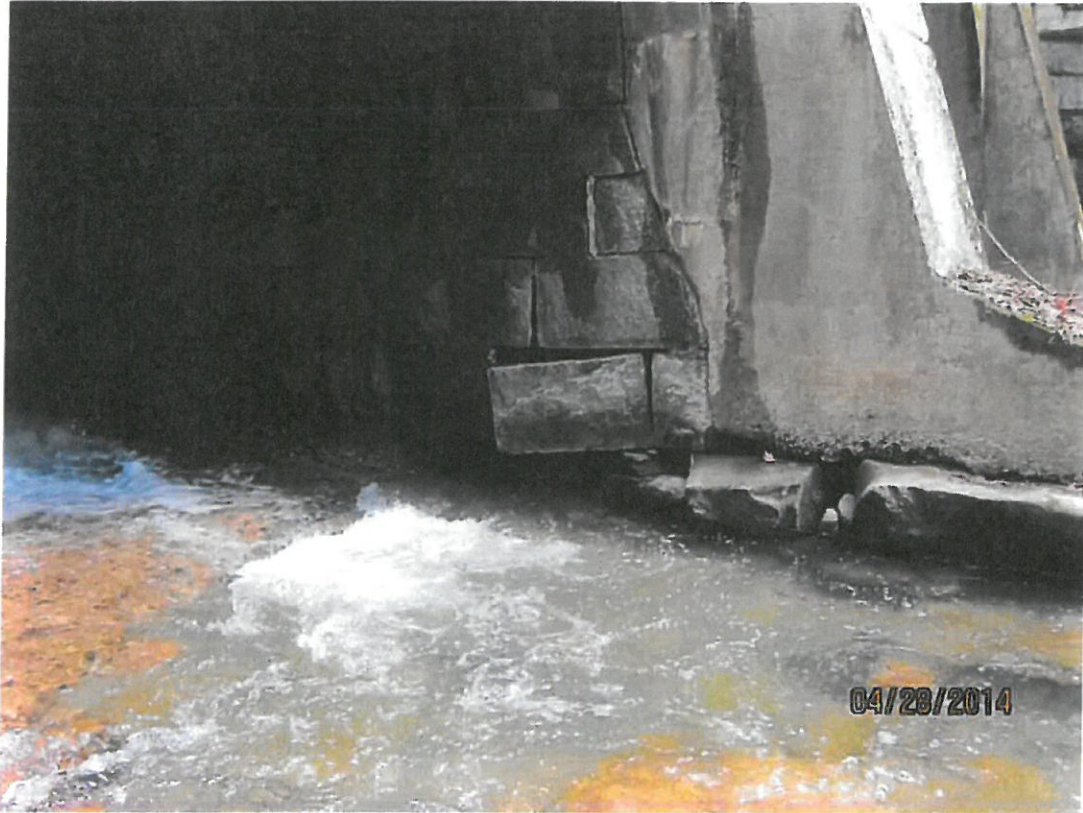
In 2014 during a reinspection of the arch following the 2013 flooding in the area, the Department found that several additional granite blocks had become dislodged at the outlet and some had been washed away. In addition, several of the blocks in the north arch were undermined and beginning to fall out. The loss of these foundation blocks inside the arch and at the spillway wall have destabilized the arch structure and may eventually cause a partial collapse similar to what happened at the Westmoreland granite arch if not remedied. In 2015, the Department performed a temporary repair to reset some granite blocks and construct a partial concrete toe wall in the north arch to stabilize the arch's foundation blocks. No repairs were made to the spillway blocks due to the lack of funding. The work inside the arch was a temporary repair until funding could be obtained to reestablish the concrete floor in the north arch, construct a new outlet spillway wall, and to repair the other arch structure issues so the arch would be in a permanent stable condition. To date that funding has not been provided.

**View of Undermined Granite Blocks in 2014**

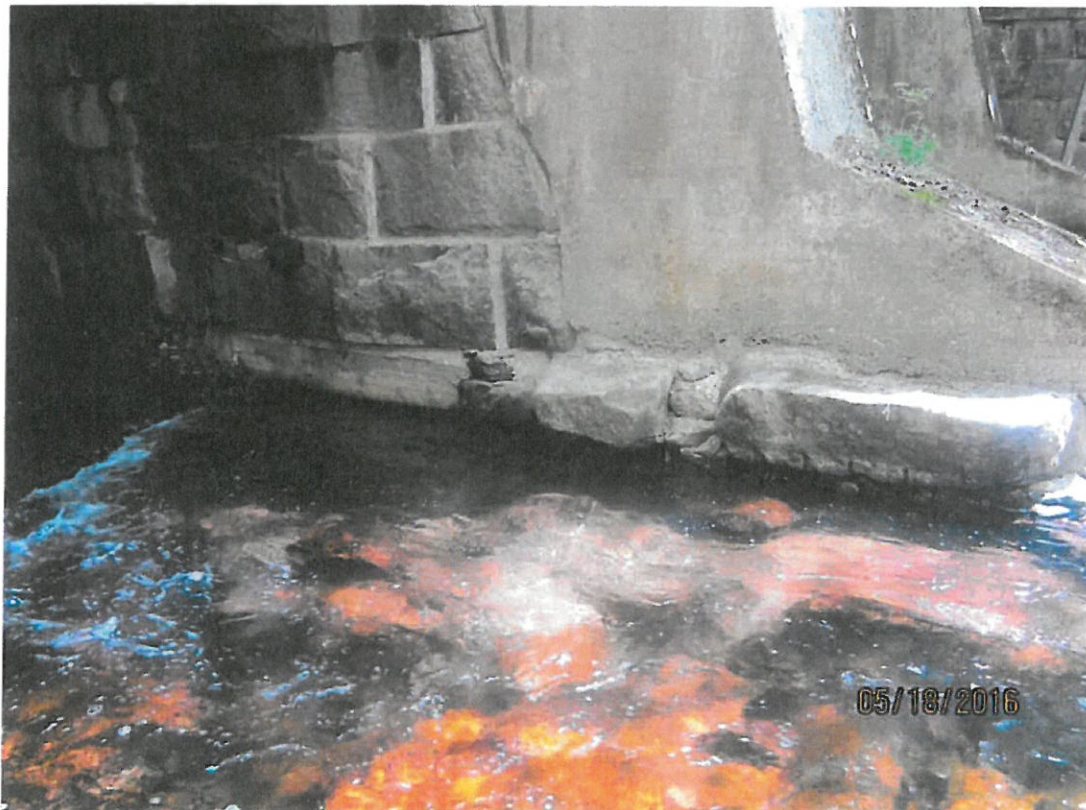
**View of Reset Granite Blocks and Concrete Completed in 2015**

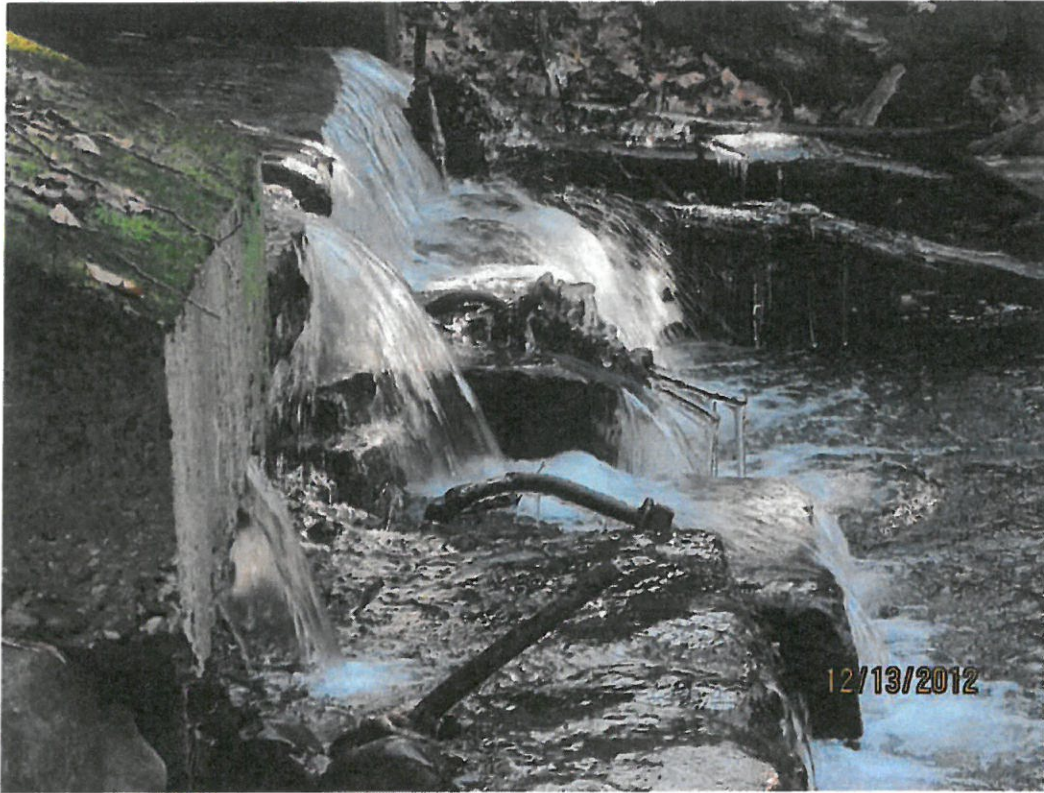
**View of South Side of Outlet Spillway Wall Showing Deterioration**

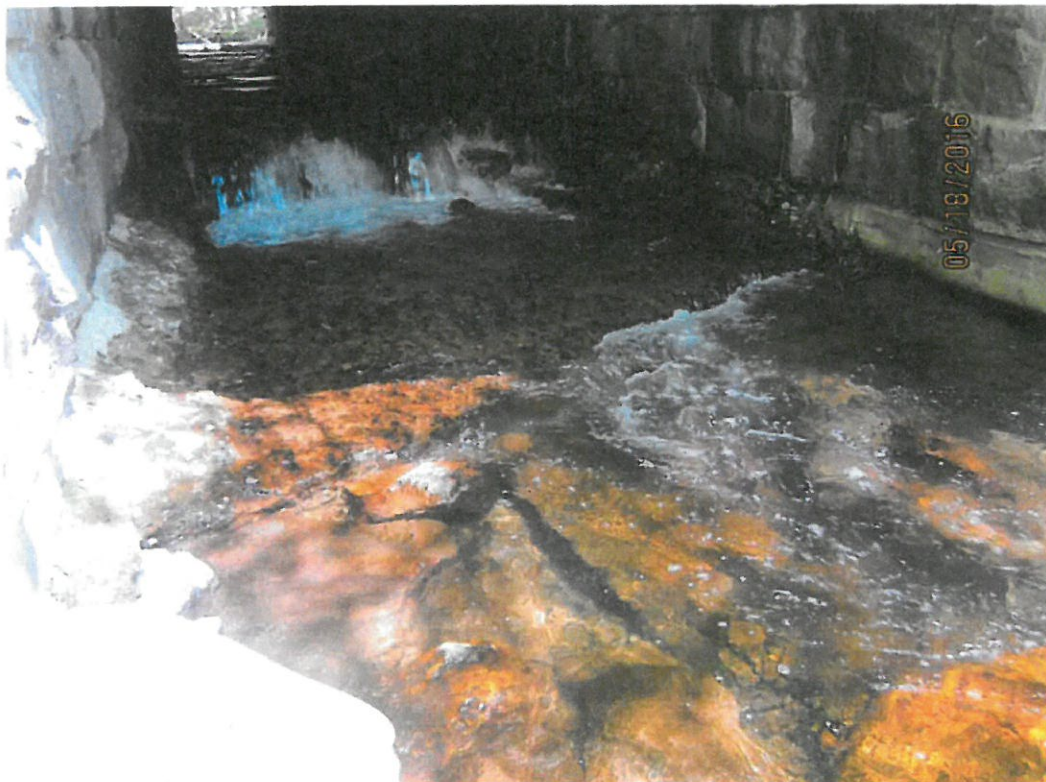
**View of Missing Floor Slabs inside the North Arch**
